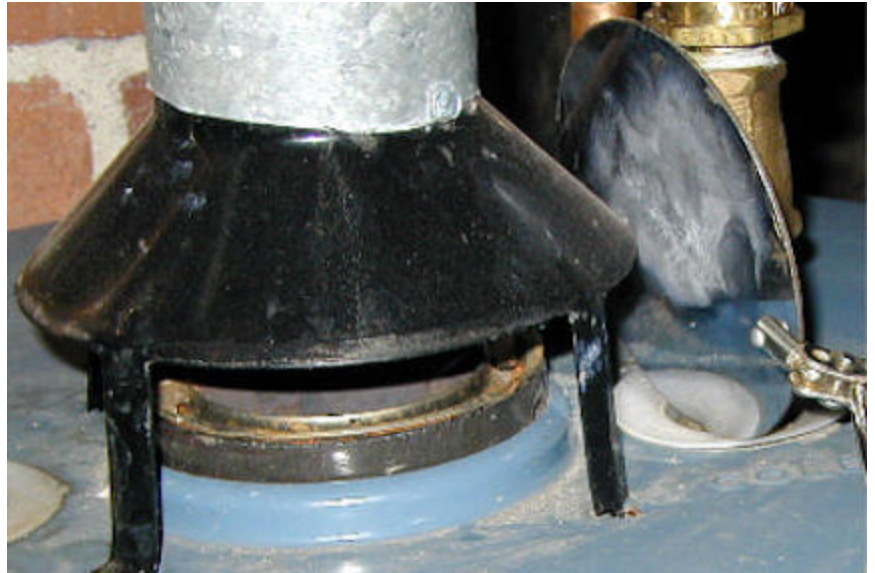
A mirror is used here to show exhaust leakage from a gas fired water heater (the mirror fogs up from the water vapor condensating on it.)

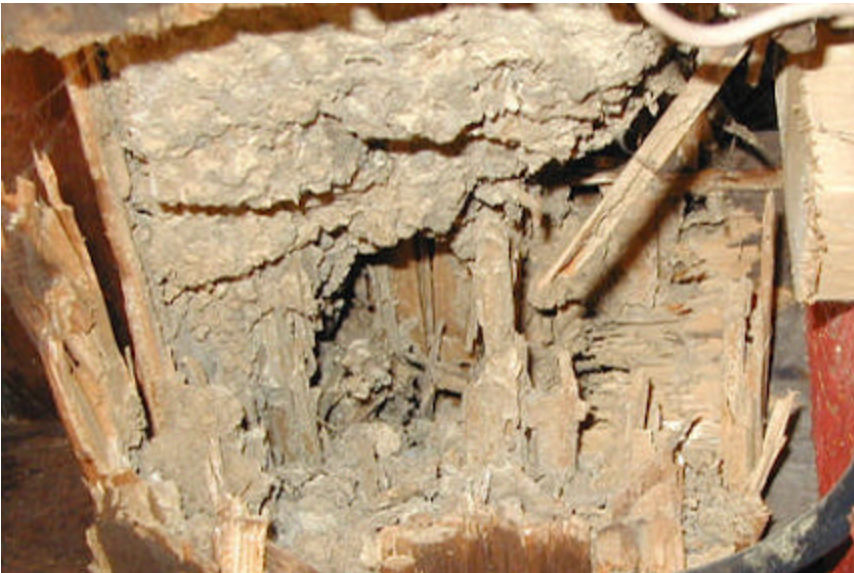
Termites cause more damage in the US than fires. This main house beam was completely eaten out.)

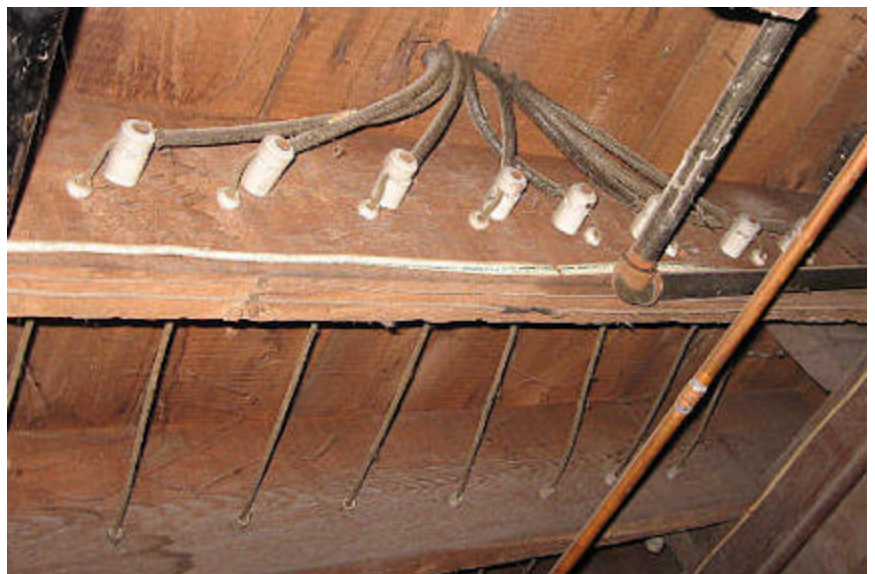
This is knob and tube wiring. It was the first wiring installed when houses first got electricity. Most insurance companies will not insure homes that have active knob and tube wiring.
